Lunar ROADSTER (Robotic Operator for Autonomous Development of Surface Trails and Exploration Routes)

"Starting with a foothold on the Moon, we pave the way to the cosmos"

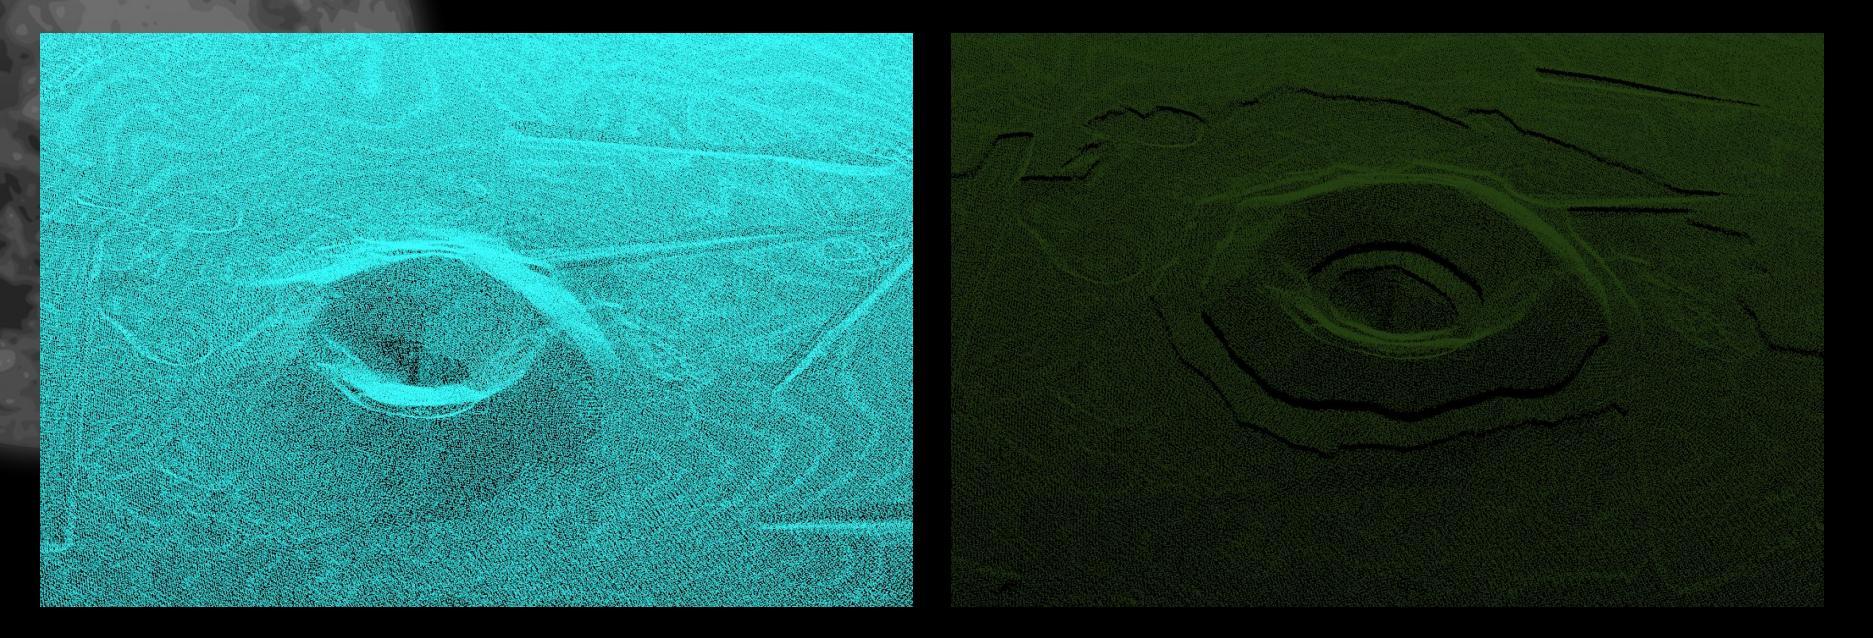
Software: Tool Planner

- Ground plane is fit using RANSAC
- Point cloud is modified to clamp small height values to 0 to allow accurate source and sink node detection

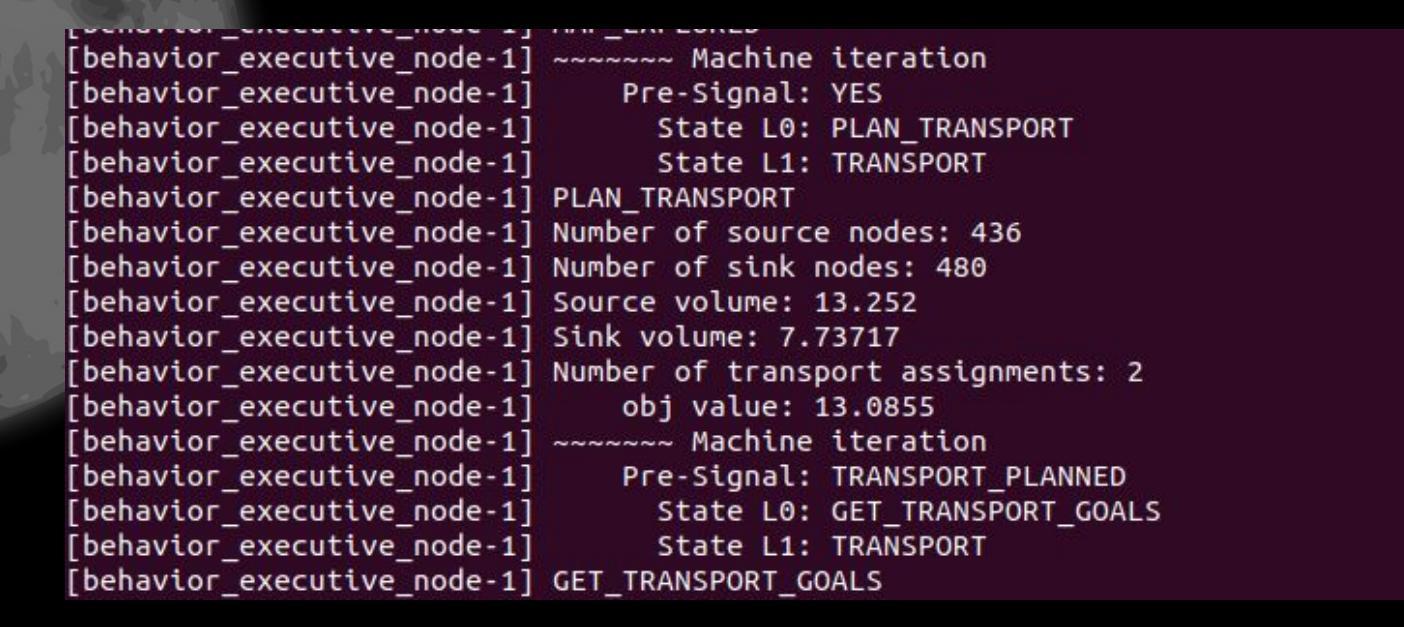
Software: Tool Planner

- Tool Planner integrated with FSM
- Next Task: Tuning Map and Planner to get the desired outputs
- Error: Source and sink volume mismatch (partially environment, partially thresholding)

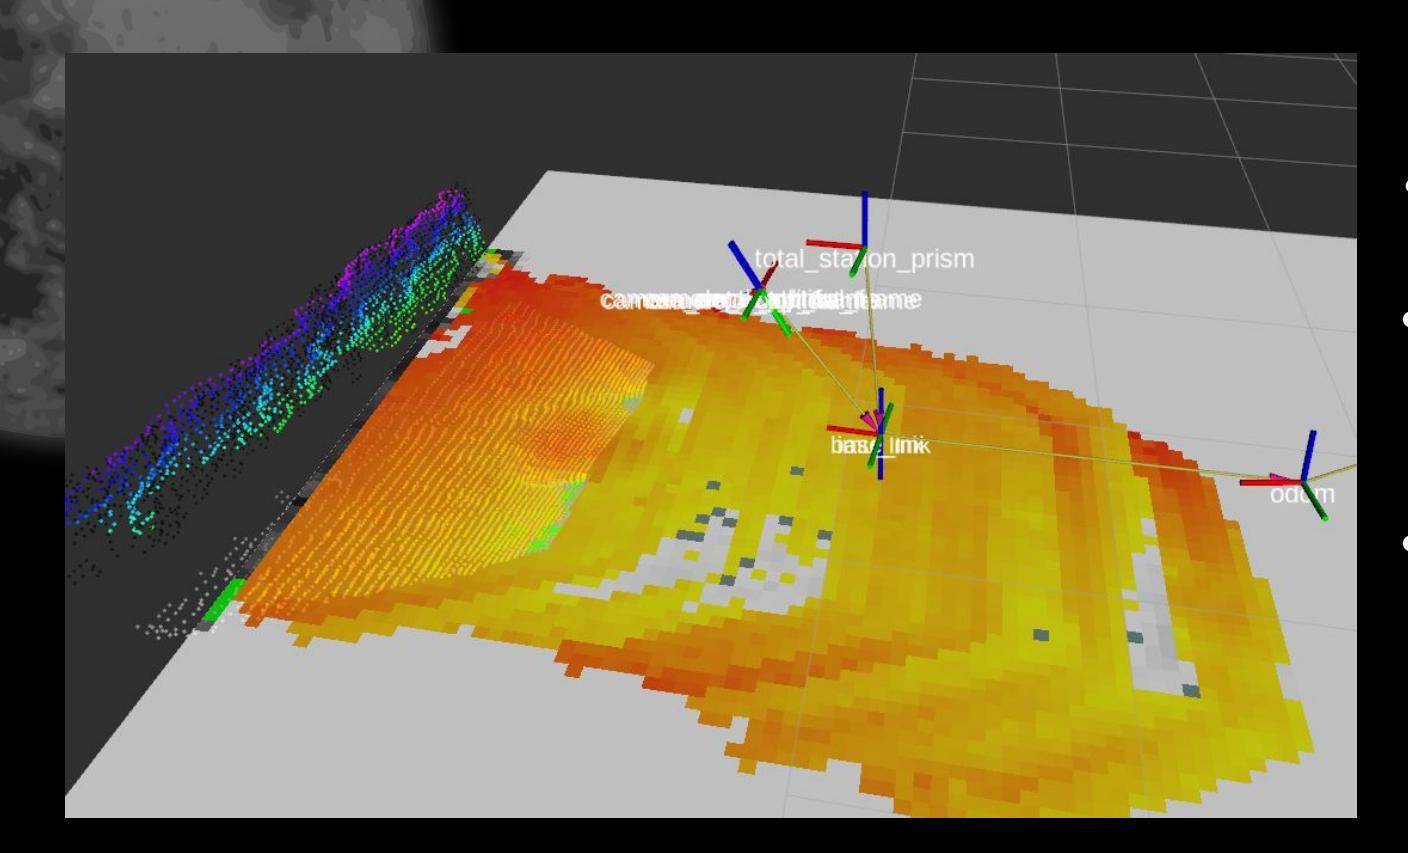
Software: Active Mapping Stack (T08)

- Active mapping stack completed
 - Integrates with localization to give global elevation map
- Local elevation map is also implemented (not shown)

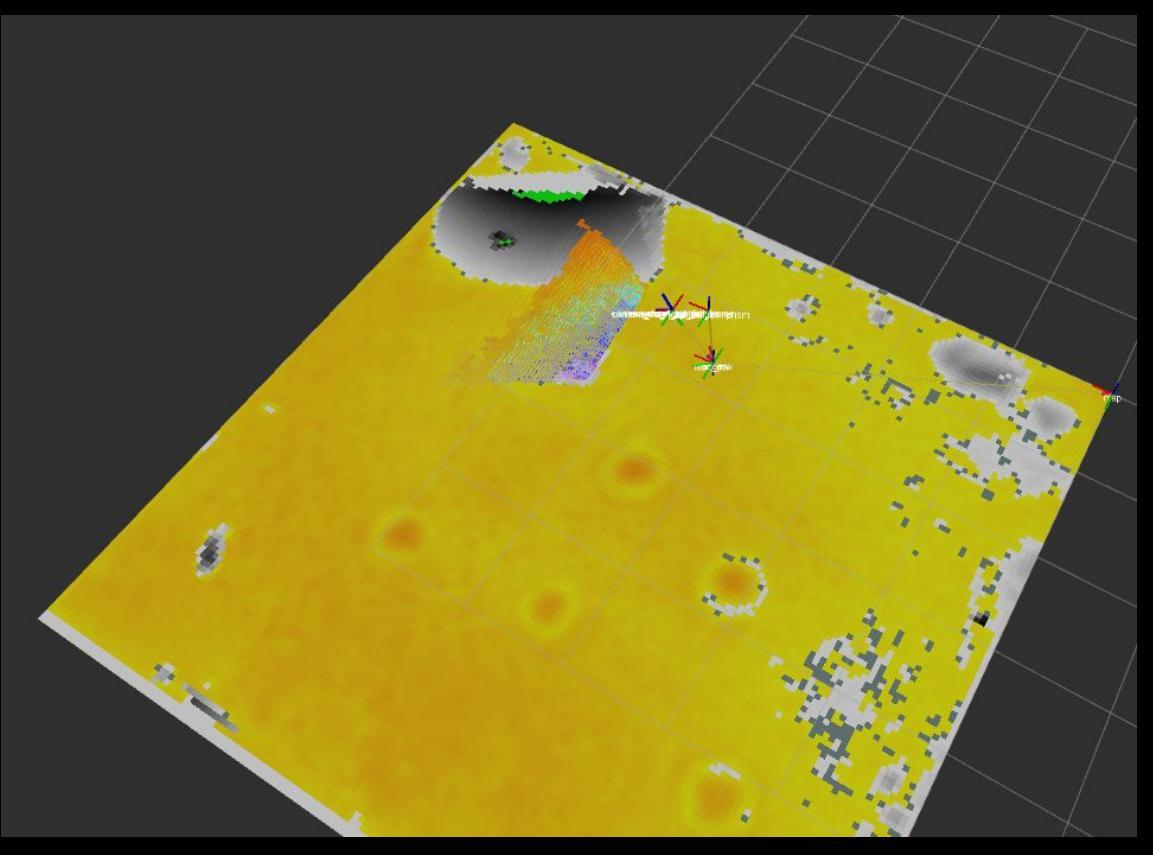
Software: Active Mapping Stack (T08)

Global elevation map can optionally be initialized with preloaded point cloud map from FARO scan

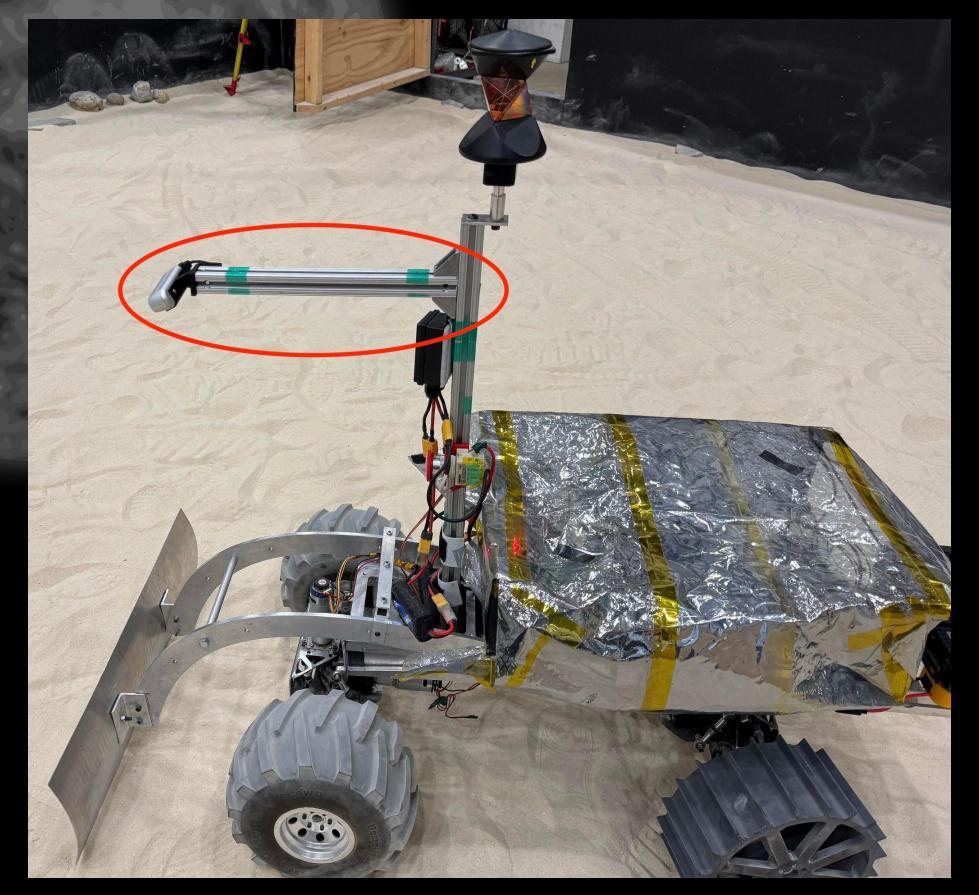
Hardware: Sensor Mounted (T10)

- RealSense camera mounted at {X, Y, Z, R, P, Y} = {0.5, 0, 0.6, 0, -30, 0} from base_link
- FOV is clear of the dozer blade
- Extrusion does not affect total station localizing the prism
- Triangle bracket mount is sturdy

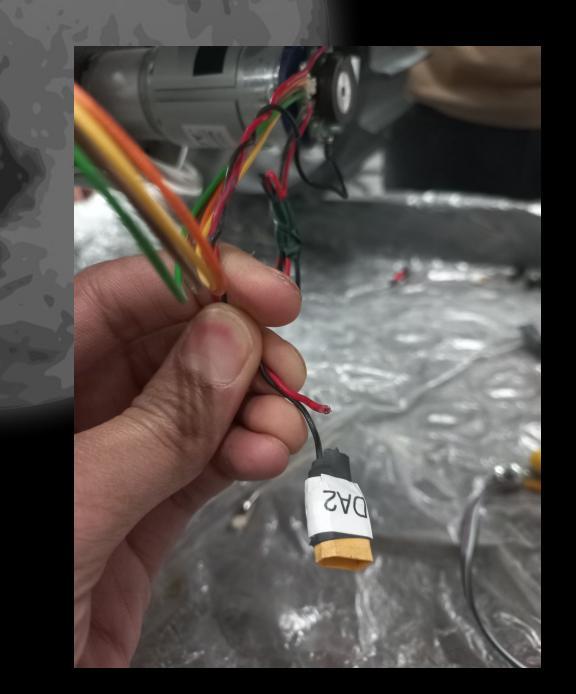
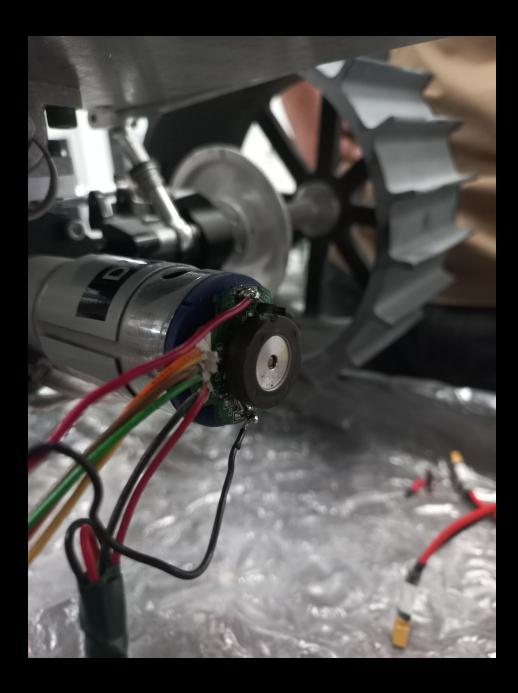
Hardware: Quality Assurance (T14)

- Fixed loose connections
- Re-crimped and re-soldered worn out connections
- Fixed rear steering motor by drilling through the shaft and using a dowel

pin to hold the pinion in place.
